Manhole Inspection Summary

Manhole # S39U1_003MH

Location Address: **3501 3 rd St**

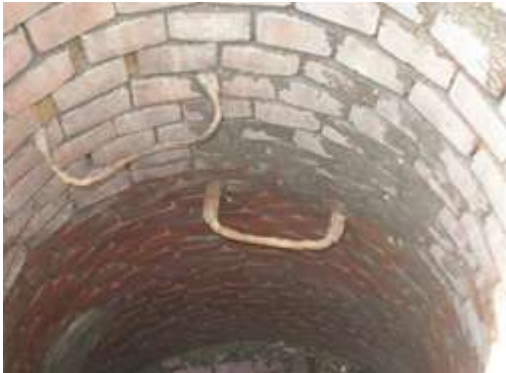
Steps Count: **6** Missing: **4** ☐ Corroded

steps

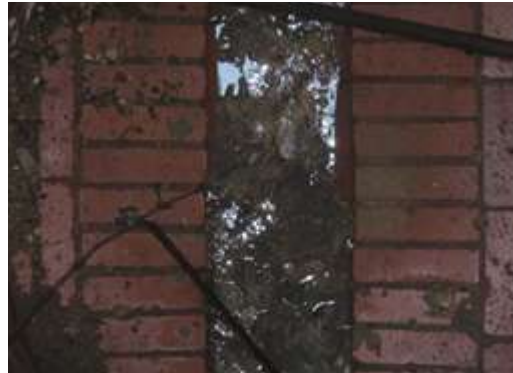
Defect 2

heavy debris in channel

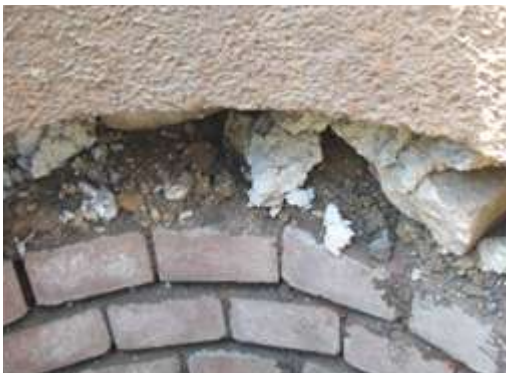
Defect 1

Condition: ☐ Sound ☐ Cracked ☐ Root Intrusion ☒ **Loose Brick** ☐ Deteriorated

Loose bricks in chimney

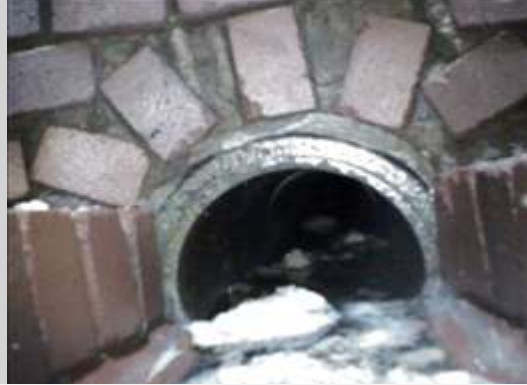
12 O'Clock Outflow

Pipe Height: **8.4** (in.) Rod and Bar (Angled)
Pipe Material: **Clay** ☐ Pipe Lined
Invert Depth: **10.16** (ft.) Flow Characteristics: **Slow**
Deposits: ☐ None ☐ Mud ☒ **Sludge** ☐ Debris ☐ Grease
Silt Depth: **6** (in.) Deposits Extent: **Heavy**
Infiltration: **None** Pipe Seal Cond: **Sound**

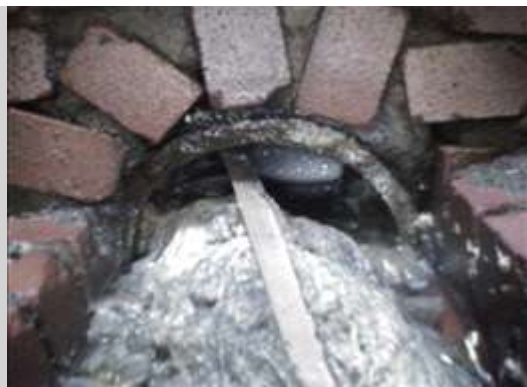
6 O'Clock Inflow

Pipe Height: **8.4** (in.) Rod and Bar (Angled)
Pipe Material: **Clay** ☐ Pipe Lined
Invert Depth: **10.30** (ft.) Flow Characteristics: **Slow**
Deposits: ☐ None ☐ Mud ☒ **Sludge** ☒ **Debris** ☐ Grease
Silt Depth: **6** (in.) Deposits Extent: **Heavy**
Infiltration: **None** Pipe Seal Cond: **Sound**

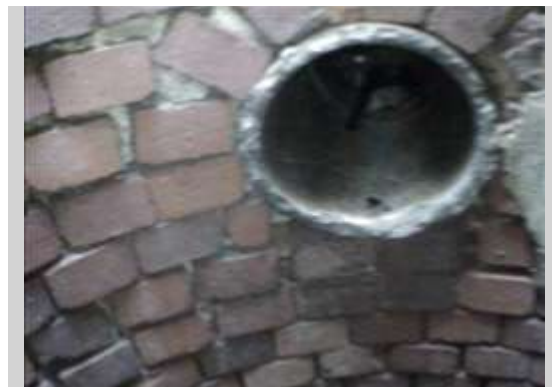
Drop In @ 6 O'Clock

Drop: **Outside** Rod and Bar
Angled: **Yes** Reading: **9.40** (ft.)
Inv Depth: **10.40** (ft.)
Drop Condition: **Open**
